PORT MORESBY PAPUA NEW GUINEA UPPER AIR STATION

TECHNICAL EVALUATION

OF PRESENT OPERATION AND FUTURE NEEDS

METEOROLOGICAL SERVICE OF NEW ZEALAND LIMITED

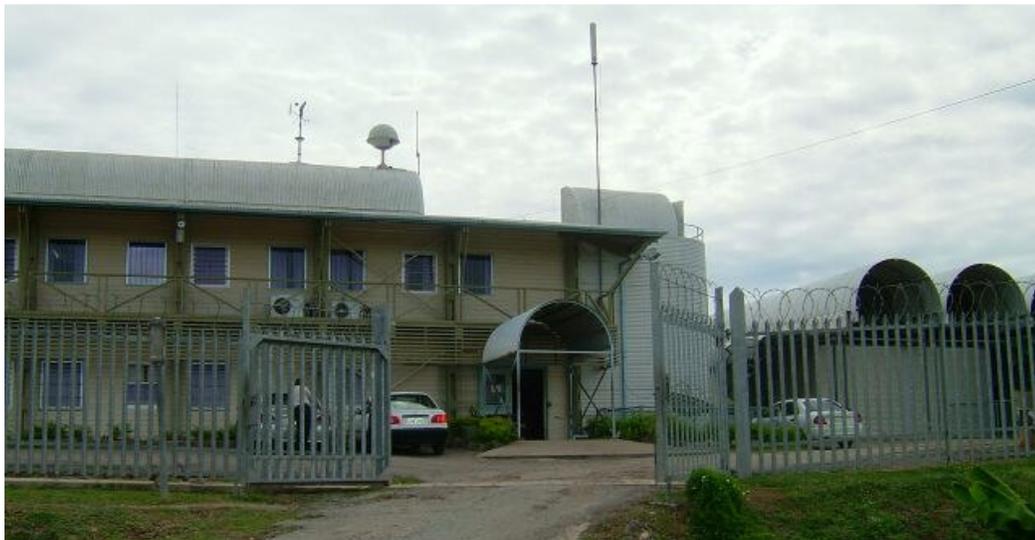
Headquarters, end of abandoned partly-constructed technical building – right hand side, security fence

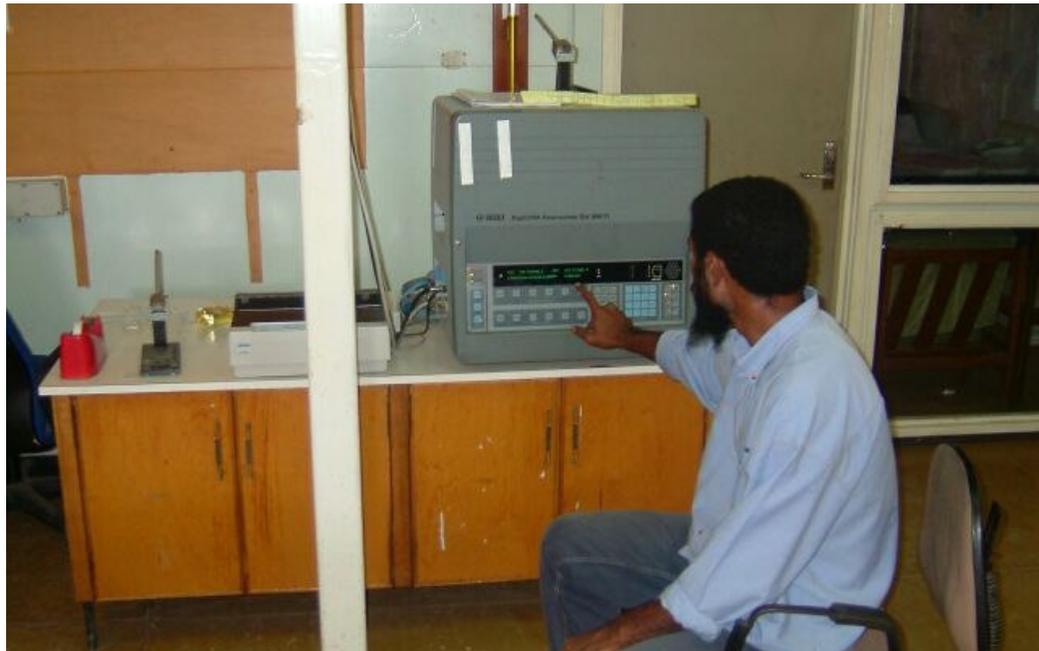
Fully serviceable and recently upgraded for RS92 radiosondes. It should be noted however, that almost no spares for this are held by the meteorological service and Vaisala have announced the discontinuation of support for this model from, we believe, 2007. (Some spares from the TSP Digicora Mk II pool are able to be used in the Mk I).

Digicora operation

The Vaisala Digicora I ground station will soon be “officially” unsupported by Vaisala. It was recently overhauled and upgraded by the Bureau of Meteorology. No spares are held on site. For now we recommend that the TSP provides parts and technical support to the extent possible, and that any failures that are unable to be supported by TSP resources at the time be subject to a support decision on a case by case basis.

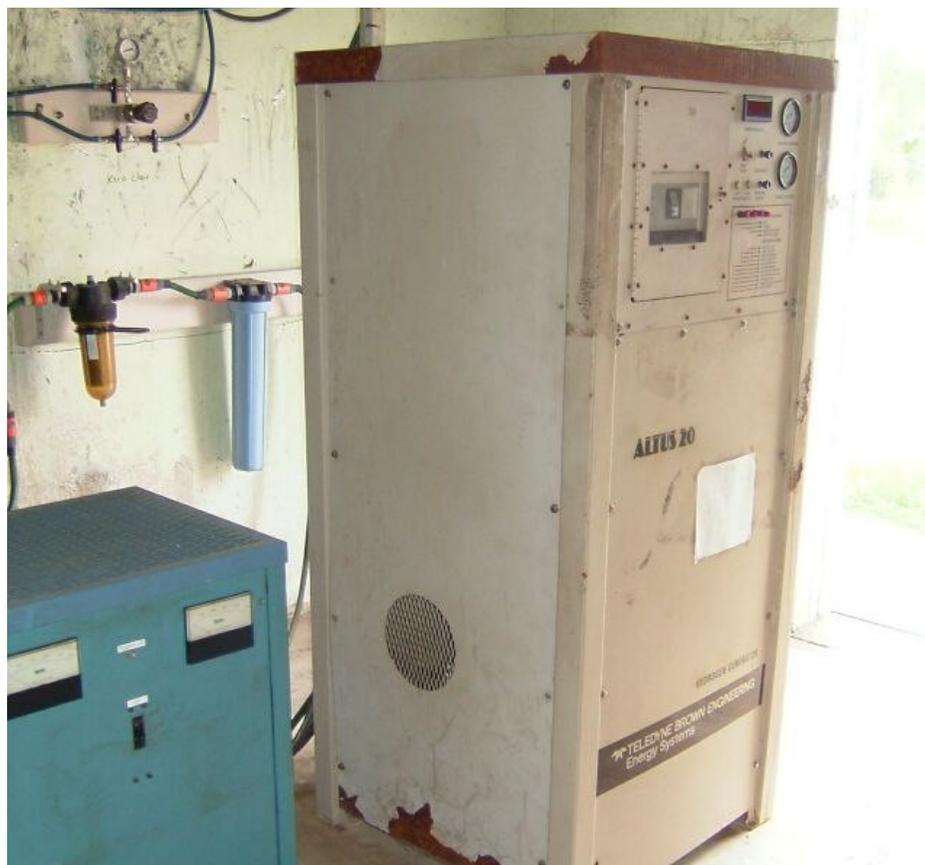
Teledyne hydrogen plant and power supply

No further work has been done on the new buildings, and the temporary installation remains. The plant is still working, although the corrosion is a lot more advanced. It is obviously not designed for this tropical environment, as the panels, frame, and other items are made of painted mild steel and not stainless steel. Its design includes some undesirable features such as corrosive electrolyte, lack of combustible gas detection for leaks, and questionable intrinsic safety. Some internal components (cooling stacks, etc) are also showing signs of corrosion.

The hydrogen production rate is well down (eight cubic feet per hour instead of 20). Apparently some time ago the supplies of mixed bead resin (demineralising chemical) were depleted and to keep the plant operating it was necessary to temporarily isolate the water purity monitor circuit and use untreated water. We suspect that this has damaged the cell stack and is causing the poor production outputs.

We do believe it is important that some form of water purification or filtration system be provided. Ideally, we would recommend an Aqua Solutions unit, as would be necessary (in our view) for a Proton unit. Funds can be saved, though, by simply ensuring that a supply of mixed bead resin cartridges are made available. These are not overly expensive and can be supported from the TSP resources. We are planning to do this.

We recommend a similar approach as that for the Ground Station except, of course, the TSP will not hold any spares. This includes an on-going supply of demineraliser cartridges funded by the TSP.

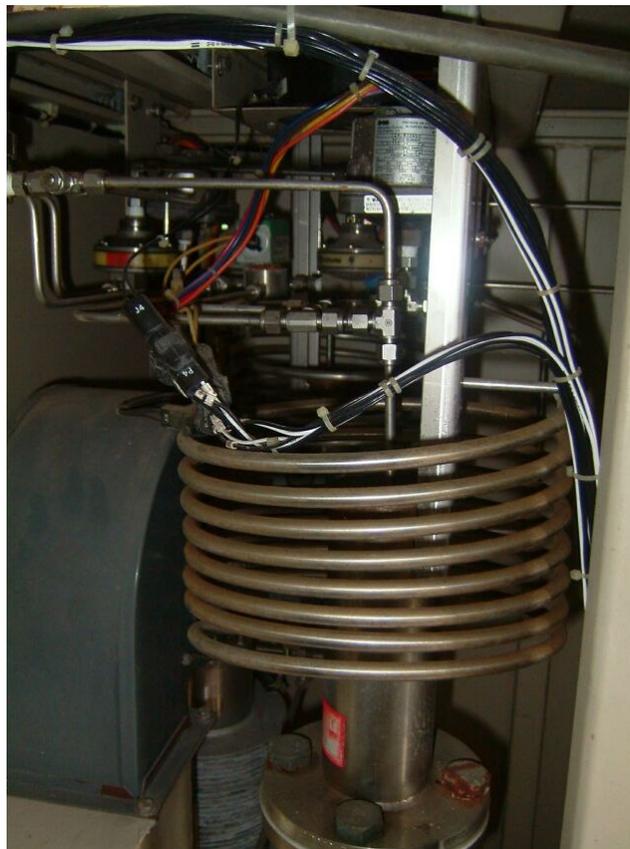
Teledyne cooling stack – some corrosion

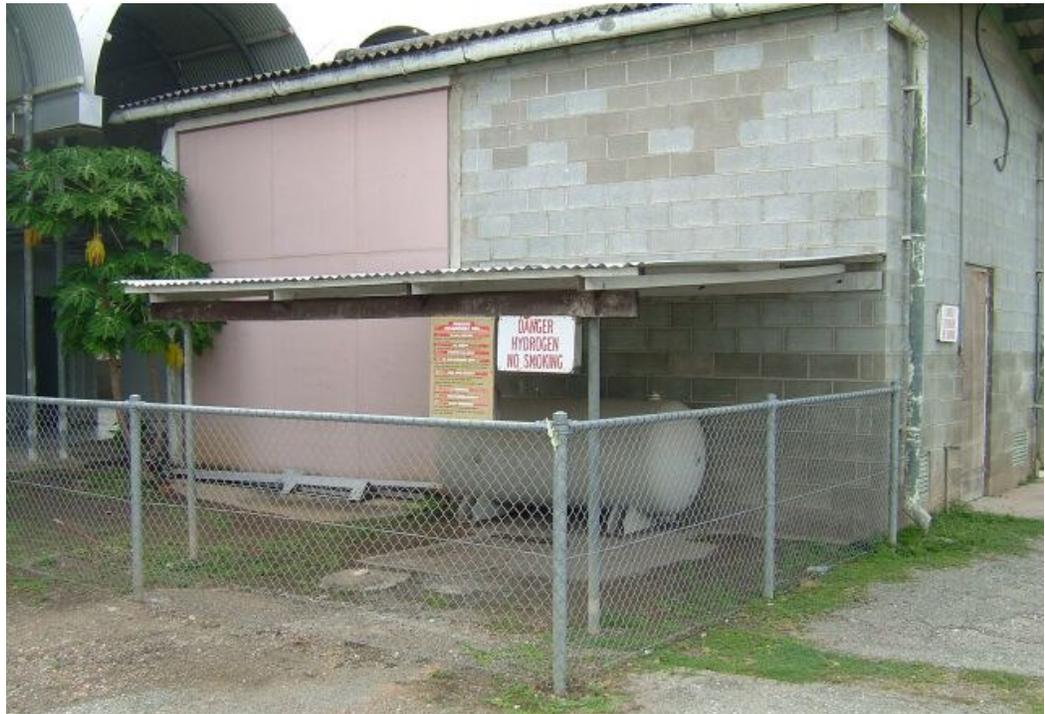
Hydrogen tank, walled up side of balloon filling bay

The tank was manufactured in 1993 and is in good physical condition. There is no record of any testing or inspection since then and we believe that none has been done.

Normal inspection requirements under New Zealand regulations for a tank of this size are an annual visual inspection, 10 yearly pressure testing and pressure relief valves testing and certifying every five years. An ultrasonic inspection is recommended every five years. This work should be carried out by suitably qualified personnel.

The Papua New Guinea regulatory requirements pertaining to this were unknown and the meteorological service staff agreed to investigate this further. As with other developing countries we suspect that there will not be any. If any work is required then funding assistance would be necessary. We suggest that this be considered pending the outcome of the meteorological service investigations and upon any request for assistance being made.

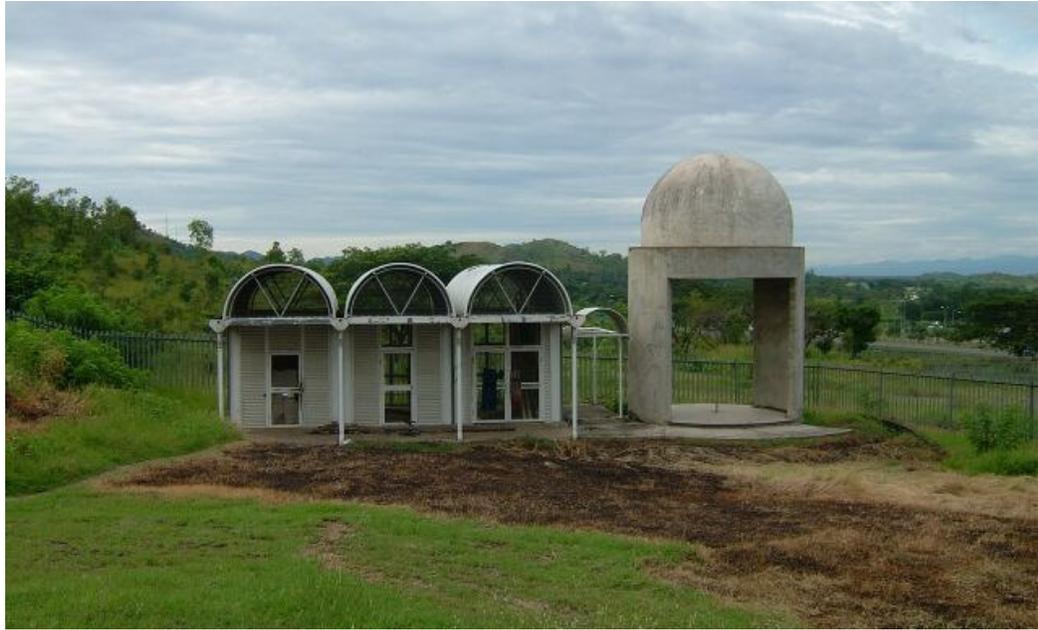
This “purpose-built” facility is located some 30 metres away from the temporary building on the boundary of the meteorological service grounds. It comprises a balloon filling bay, without doors, and a few adjacent rooms that are unfinished and, we understand, without power or water. We believe that there would be perhaps USD 10-15,000 to complete this complex and it seems hard to justify such expenditure when the program is presently operating satisfactorily from the existing site.

Abandoned partly-constructed new hydrogen building

We recommend that the existing arrangements remain.

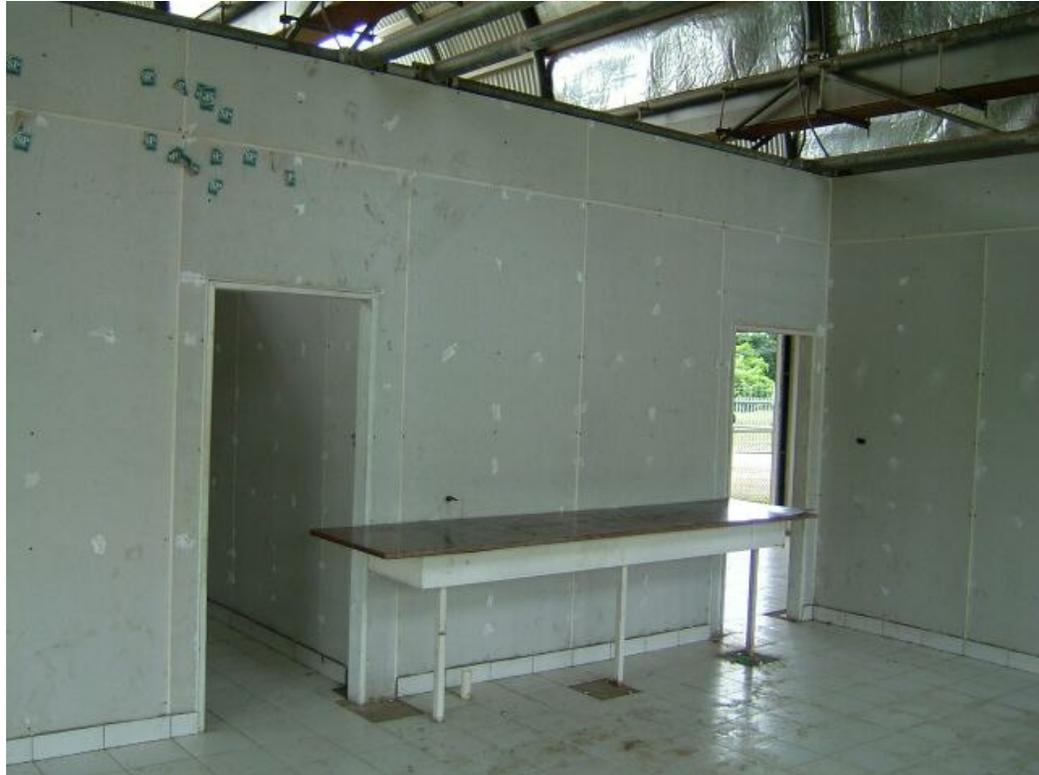
The building immediately adjacent to the temporary hydrogen and balloon filling building is the uncompleted technical workshop facility. It is open to the weather and considerable expenditure would be needed to finish this.

Abandoned partly-constructed new technical accommodation
